Garrison Diversion O&M Excels in 2019

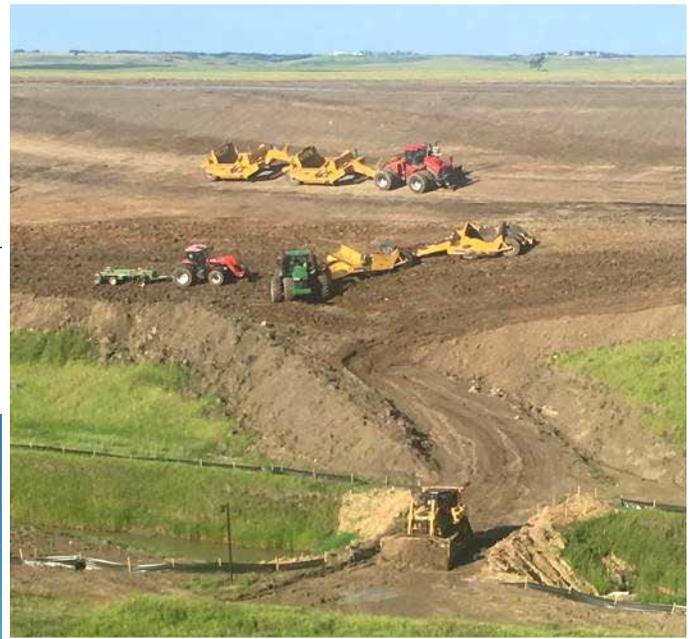
Right, removing spoil at the McClusky Canal's side-slopes.

The objective is to flatten the currently failing 2 to 1 side-slope to a more stable 4 to 1 slope. Overall, a total of 2.4 million cubic yards is estimated to be moved over the course of five to six years. In 2019, crews removed approximately 323,000 cubic yards of spoil material from the area to

stabilize the slope, bringing the total to about one million cubic yards since the project began in the fall of 2017.

O&M crews at the slide area performed earth-moving activities as well as installed silt fence, and seeded completed slopes to help with erosion control and establish vegetation. On average, five to seven workers are working the slide area. Four tractors pull two pans each, a skid steer operator removes large rock, and, on occasion, a dozer operator is on-site. This time-consuming project is important to enhancing the overall function of the McClusky Canal.

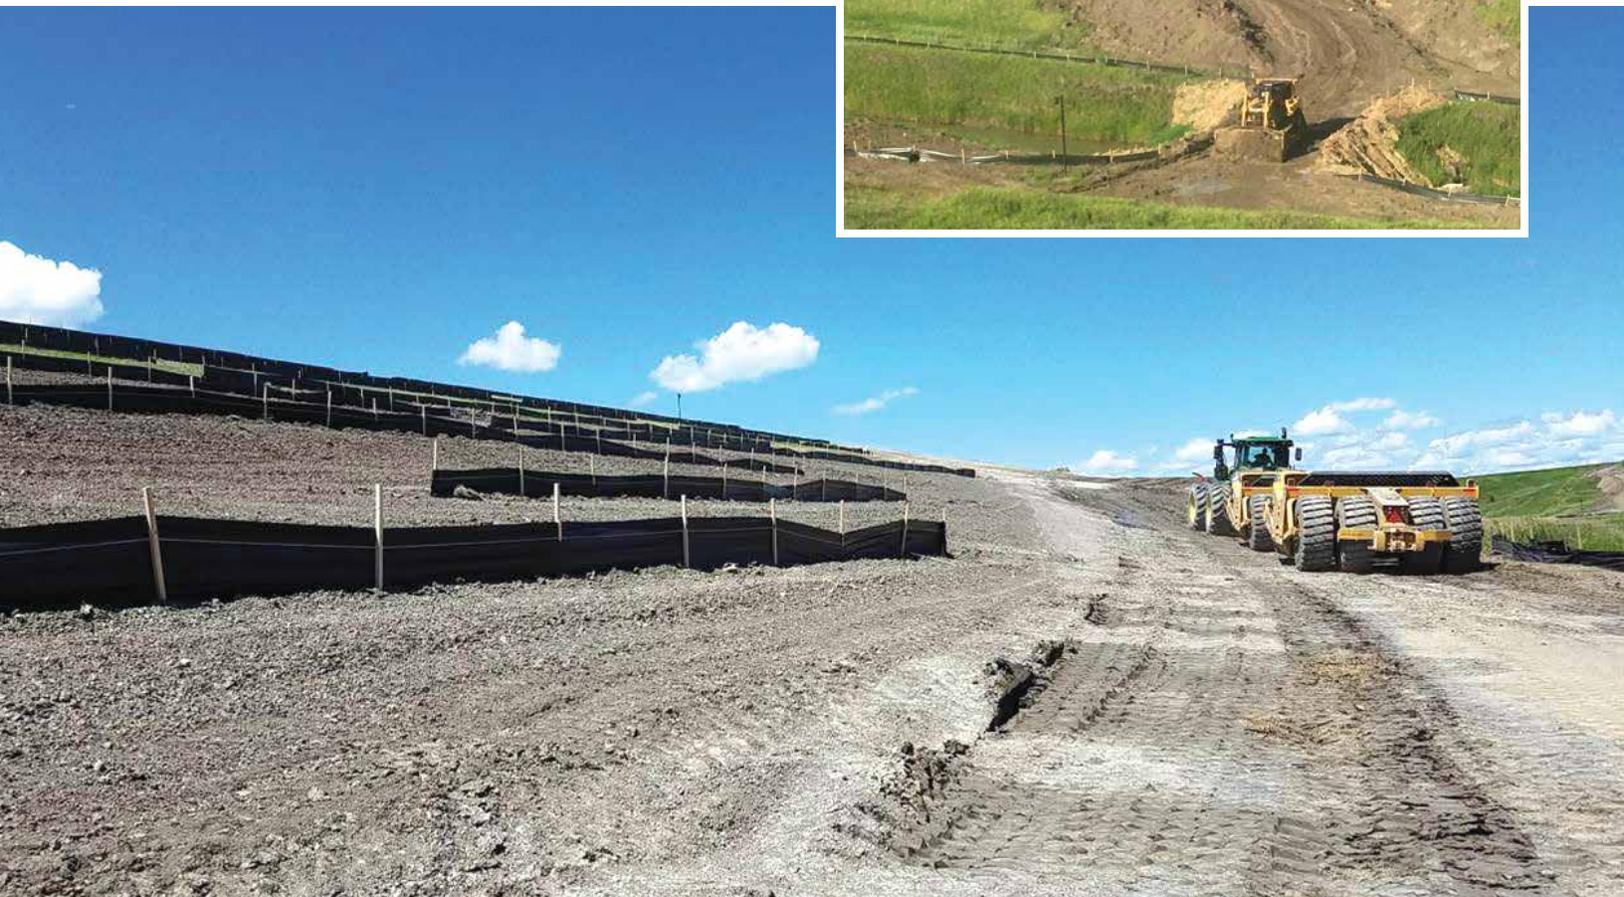
Below, silt fence installed on major slide area at the McClusky Canal.

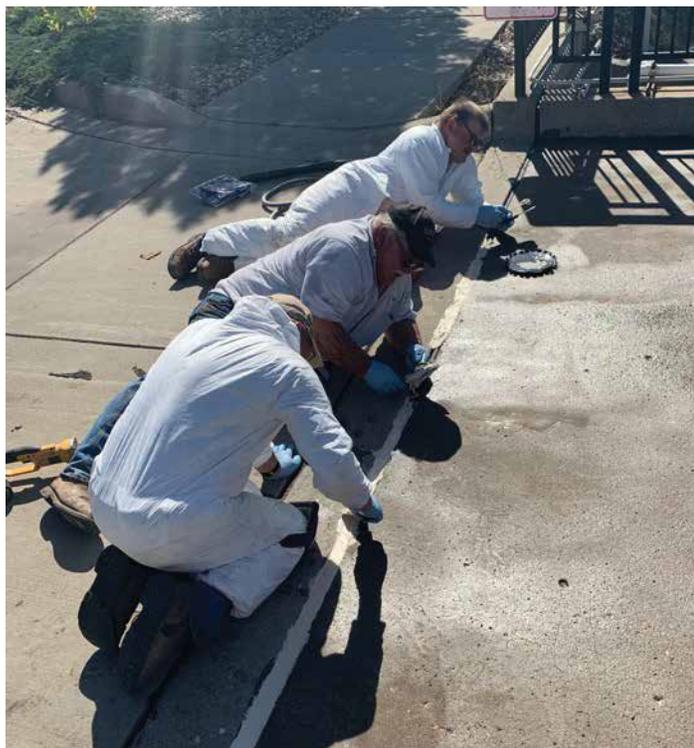
Resealing expansion joints and concrete deck maintenance activities at the Snake Creek Pumping Plant.
